DEPARTMENT OF TRANSPORTATION**DIVISION OF ENGINEERING SERVICES**

Quality Assurance and Source Inspection

Contract #: 04-0120F4Cty: SF/ALA Rte: 80 PM: 13.2/13.9File #: 69.28**WELDING INSPECTION REPORT****Resident Engineer:** Siegenthaler, Peter**Address:** 333 Burma Road**City:** Oakland, CA 94607**Report No:** WIR-021469**Date Inspected:** 05-Mar-2011**Project Name:** SAS Superstructure**OSM Arrival Time:** 700**Prime Contractor:** American Bridge/Fluor Enterprises, a JV**OSM Departure Time:** 1900**Contractor:** Zhenhua Port Machinery Company, Ltd (ZPMC), Changxing Island **Location:** Shanghai, China**CWI Name:** Li Yang**CWI Present:** Yes No**Inspected CWI report:** Yes No N/A**Rod Oven in Use:** Yes No N/A**Electrode to specification:** Yes No N/A**Weld Procedures Followed:** Yes No N/A**Qualified Welders:** Yes No N/A**Verified Joint Fit-up:** Yes No N/A**Approved Drawings:** Yes No N/A**Approved WPS:** Yes No N/A**Delayed / Cancelled:** Yes No N/A**Bridge No:** 34-0006**Component:** OBG Segments**Summary of Items Observed:**

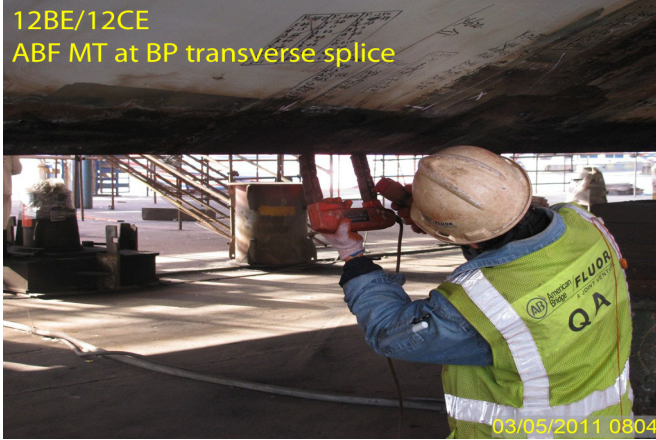
This QA Inspector observed ABF personnel performing Magnetic Particle Testing along the Bottom Plate transverse splice including locations of removed fit up plates.

12BE/12CE
ABF MT at BP transverse splice

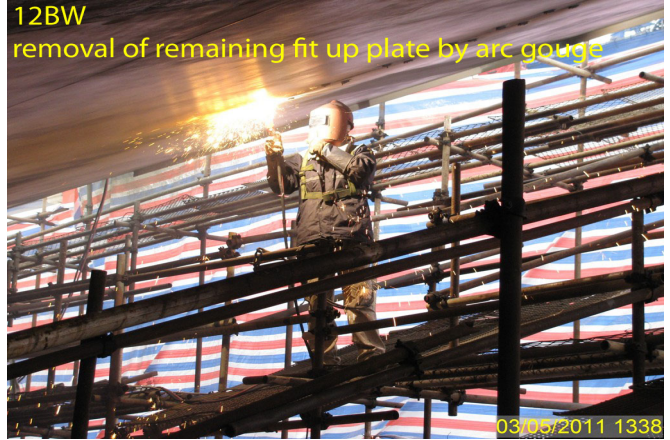
This QA Inspector observed the removal of the remaining portion of fit up plate by arc gouging from the Side Plate longitudinal splice of the segment and corner assembly, counter weight side.

12BW
removal of remaining fit up plate by arc gouge
